## Sustainable Development of Tourism in Kune-Vain Wetland System

## Abstract

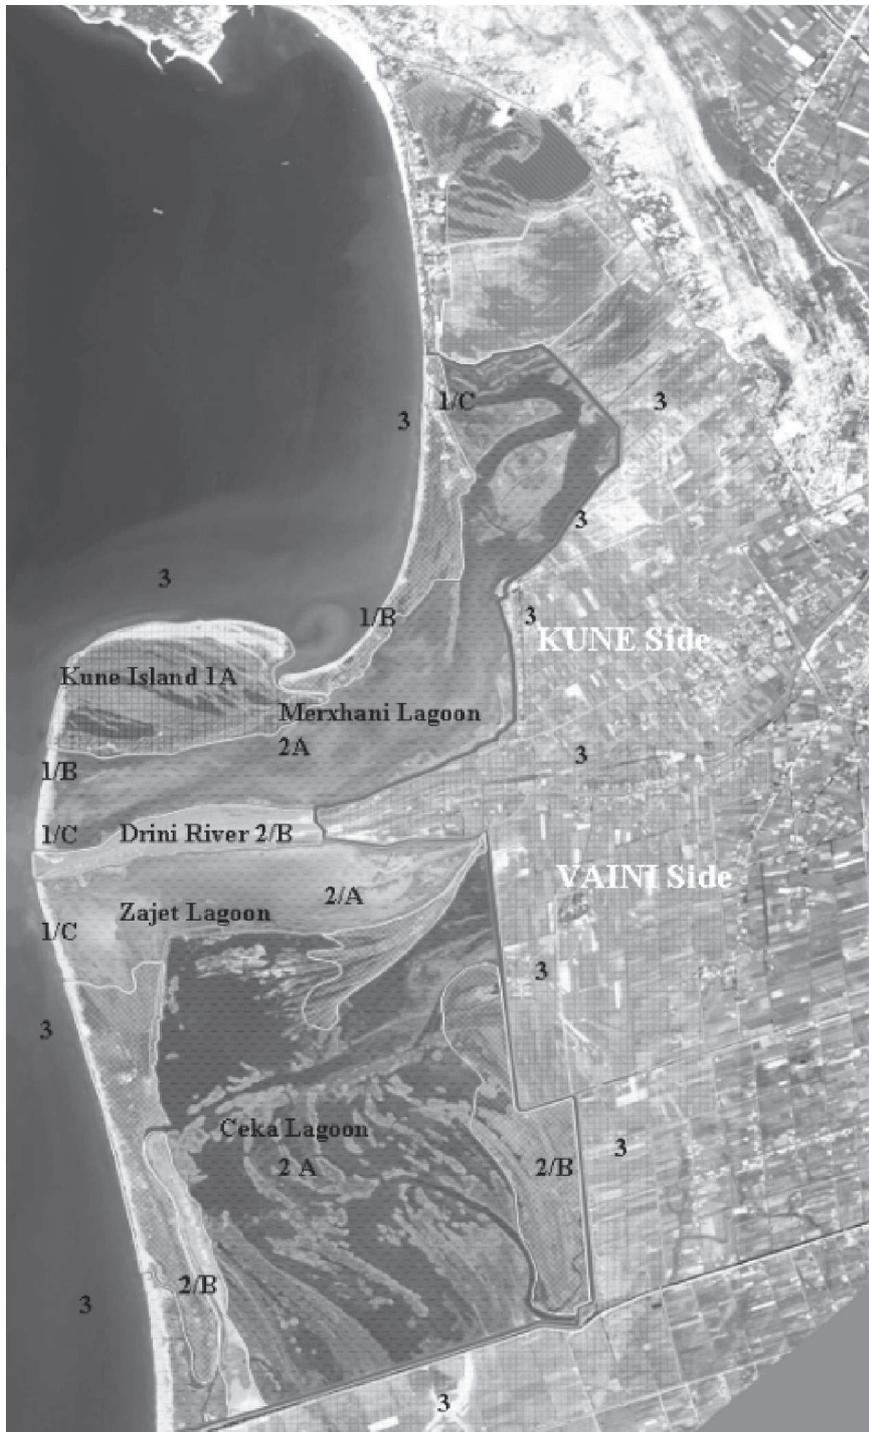
**Fig. 1. Map of proposed spatial planning of development and conservation in Kune-Vain Protected Area.**

*(Elaborated from the GIS-geo-formatted image. sc 1:10 000 Original, CEIA, 2010)*

**1/A** – Strict Protected Zone; **1/B** – Core Zone, low human presence / protective intervention; **1/C** – Core zone, controlled recreational activity / low human presence; **2/A** – Traditional development zone (fishing); **2/B** – Sustainable Development Zone-(Tourism development); **3** - Sea and Inland buffer zone (tourism infrastructure).

The Nature Reserve of Kune-Vain, is a wetland system located in the administrative district of Lezha, in the northern Albanian coast, in the latitude 41°45’N and longitude 19° 36’E . The area includes the Kune side in north of Drini of Lezha river and Vaini one in the south of the river (fig. 1). The total surface of the Kune Vain area (without Tale zone and Kenalla lagoon) is about 2000 ha.<sup>7</sup> The Kune Island (part of the Kune side) is a Strict Protected Area<sup>8</sup> (fig.1), and according Albanian environmental legislation, the tourism can not be applied there.<sup>9</sup> The area is bordered by Shengjini beach and Ishull Shengjini village, Ishull Lezha village, Tale village and Tale beach etc.
